Orange County Environment and Agricultural Center Preliminary Study

Orange County Asset Management Services

HH Architecture
August 31, 2016
HH Project #15-082

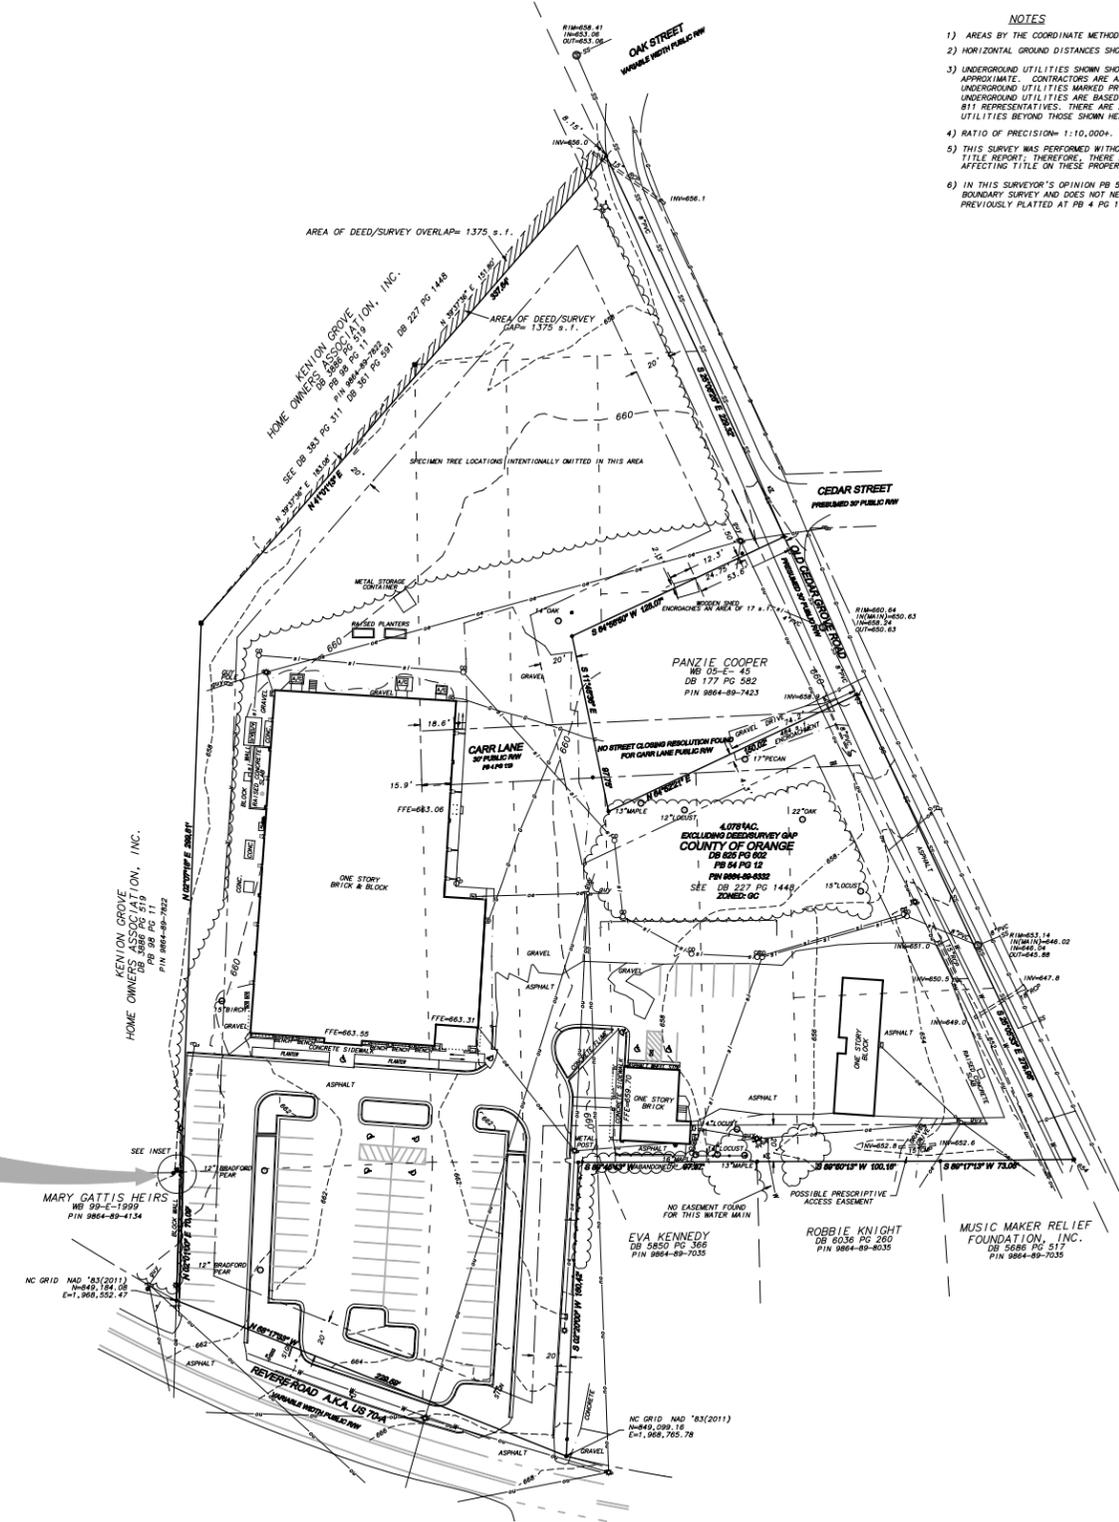
- NOTES**
- 1) AREAS BY THE COORDINATE METHOD.
 - 2) HORIZONTAL GROUND DISTANCES SHOWN.
 - 3) UNDERGROUND UTILITIES SHOWN SHOULD BE CONSIDERED APPROXIMATE. CONTRACTORS ARE ADVISED TO HAVE ALL UNDERGROUND UTILITIES MARKED PRIOR TO ANY EXCAVATION. UNDERGROUND UTILITIES ARE BASED ON FIELD MARKINGS BY 811 REPRESENTATIVES. THERE ARE ADDITIONAL UNDERGROUND UTILITIES BEYOND THOSE SHOWN HEREON.
 - 4) RATIO OF PRECISION= 1:10,000.
 - 5) THIS SURVEY WAS PERFORMED WITHOUT THE BENEFIT OF A TITLE REPORT; THEREFORE, THERE MAY BE ENCUMBRANCES AFFECTING TITLE ON THESE PROPERTIES NOT SHOWN HEREON.
 - 6) IN THIS SURVEYOR'S OPINION PG 54 PG 12 IS A PERMETER BOUNDARY SURVEY AND DOES NOT NECESSARILY RECOMBINE INTERIOR LOT LINES PREVIOUSLY PLATTED AT PG 4 PG 119 AND DEEDED IN DB 177 PG 580.
