Phase I Environmental Site Assessment

Mace Site

6517 U.S. Highway 70
Mebane, Orange County, North Carolina
HEnv Project #201603

Prepared for:
Oakwood Solar Farm, LLC
4150 Saint Johns Parkway, Suite 1000
Sanford, Florida 32771

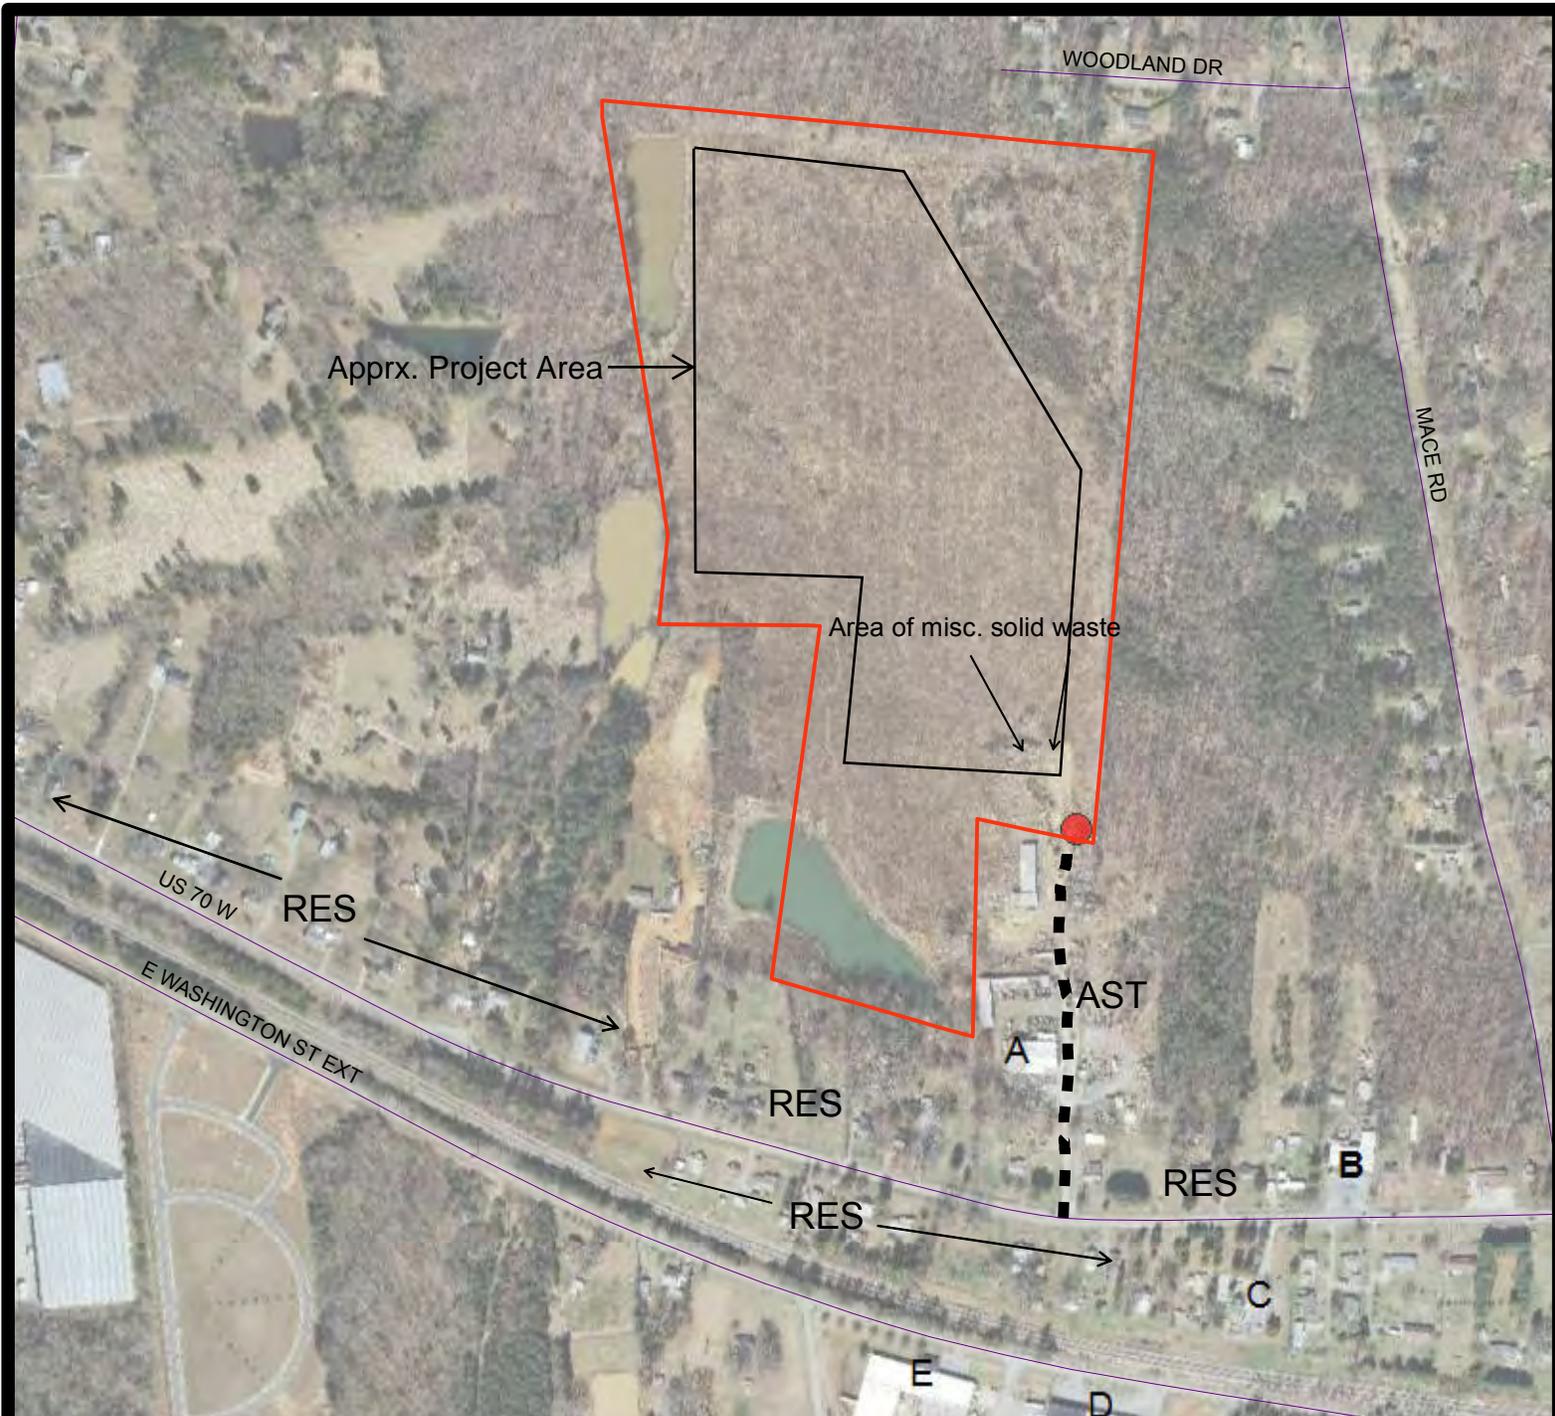
- Site Boundary
- Access Road
- AST Two ~10,000-gal diesel ASTs
- REC Area of stained soil, empty ASTs, 5-gallon motor oil buckets, and partially full 55-gallon drums (contents unk.)
- A** Mace Grading and Contracting
- B** Automotive repair facility
- C** Down Home Garden Center
- D** Pak-Lite
- E** Forma-Fab Metals
- RES** Residential

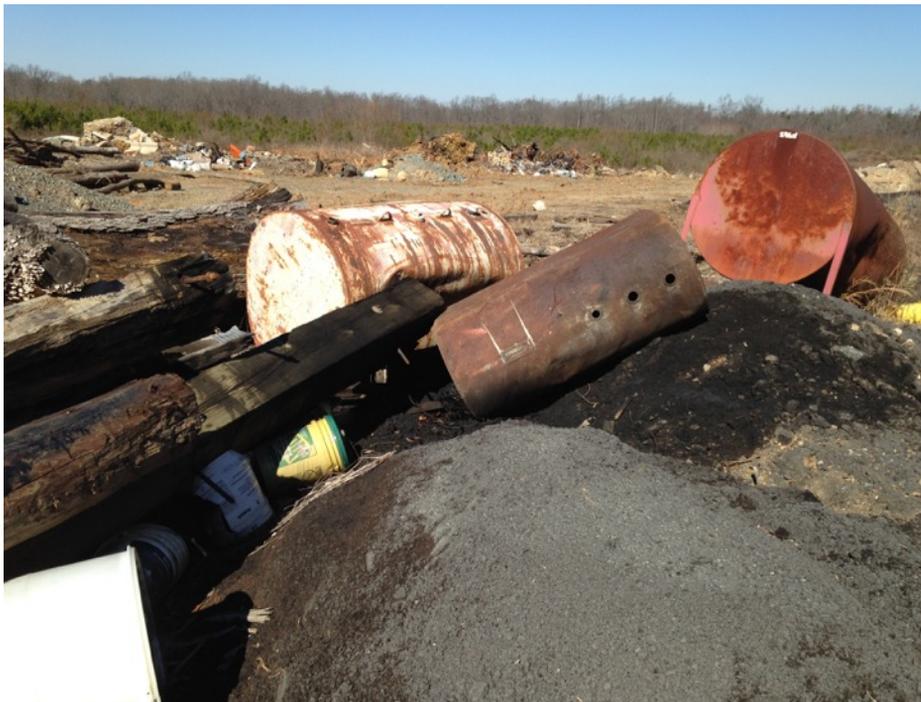
HEnv observed three empty ASTs (varying between 250-gallon and 1,000-gallons in volume), six 55-gallon drums (contents unknown), and seven empty 5-gallon motor oil buckets. Petroleum stained soil was observed around the perimeter of the ASTs, drums, and buckets. The area of stained soil represents a REC of the site.

Area of petroleum staining and empty ASTs on the southeast portion of the site.

area of stained soil represents a REC of the site. Presuming the area of stained soil is outside the project area, further assessment may not be warranted.

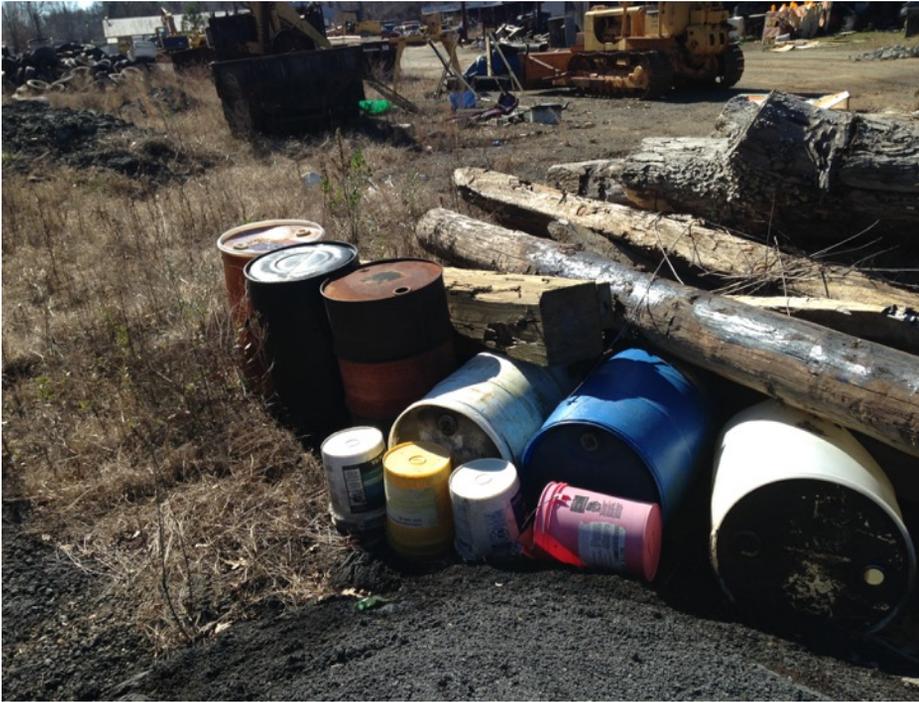
Assorted 55-gallon drums (contents unknown) and empty 5-gallon motor oil buckets on the southeast portion of the site.

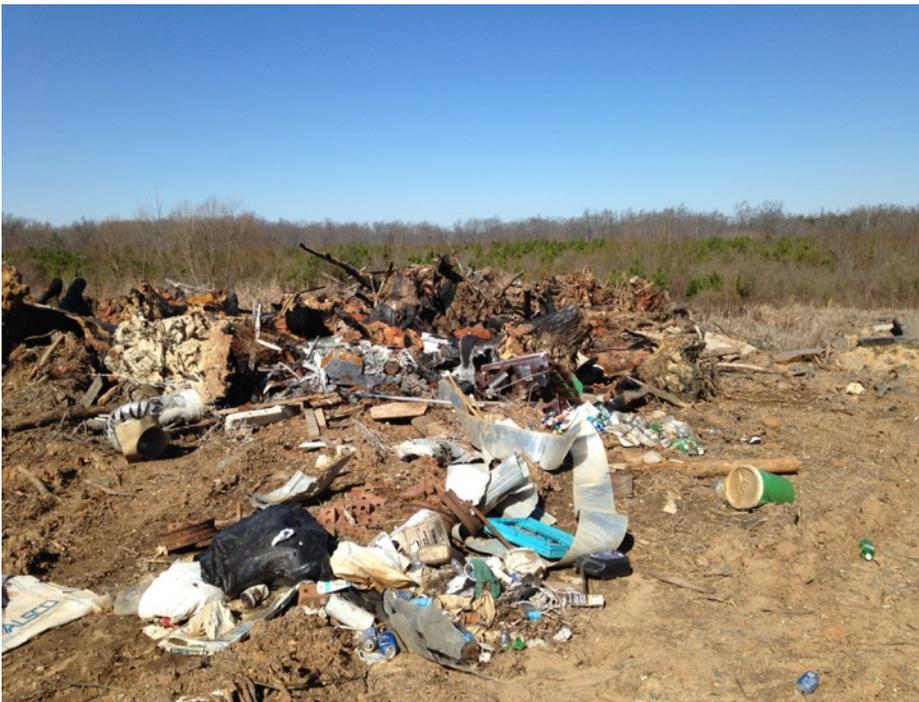
Piles of miscellaneous solid waste were observed on the southeast portion of the site. The solid waste piles are substantial and include asphalt, timber, gravel, concrete/construction rubble, 12-inch corrugated plastic piping, cardboard, aluminum cans, plastic bottles, and other assorted trash. The miscellaneous solid waste appears to be surficial. Proper removal of the miscellaneous solid waste represents a BER of the site.

Pile of miscellaneous solid waste on the southeast portion of the site.

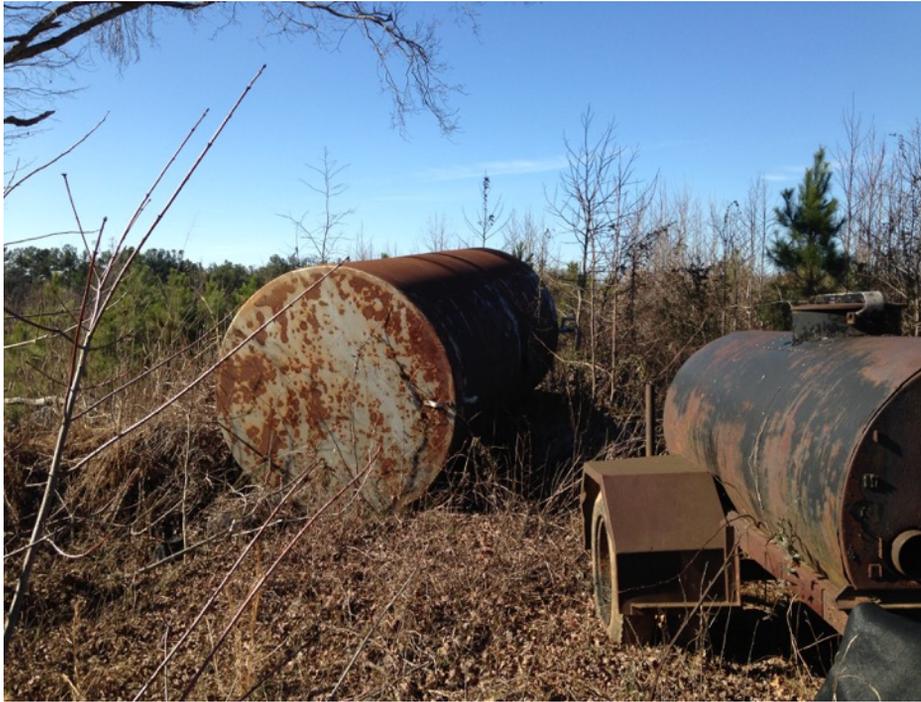
Additionally, HEnv observed an approximate 10,000-gallon empty AST on the southern portion of the site, north of the pond. Neither stained soil, nor evidence of a leak was observed around the empty AST. The approximate 10,000-gallon AST does not represent a REC of the site.

Empty AST on the southern portion of the site, north of Pond B1.
