Reference: Oakwood Solar Farm – Mace Site
6517 U.S. Highway 70
Mebane, Orange County, North Carolina
HEnv Project #201603

Headwater Environmental, Inc. (HEnv) is pleased to provide the results of our wetland delineation. On February 8, 2015, Oakwood Solar Farm, LLC retained HEnv to perform a wetland delineation at the above referenced property. The purpose of this report is to document and locate the extent of wetlands and streams within the site boundary.

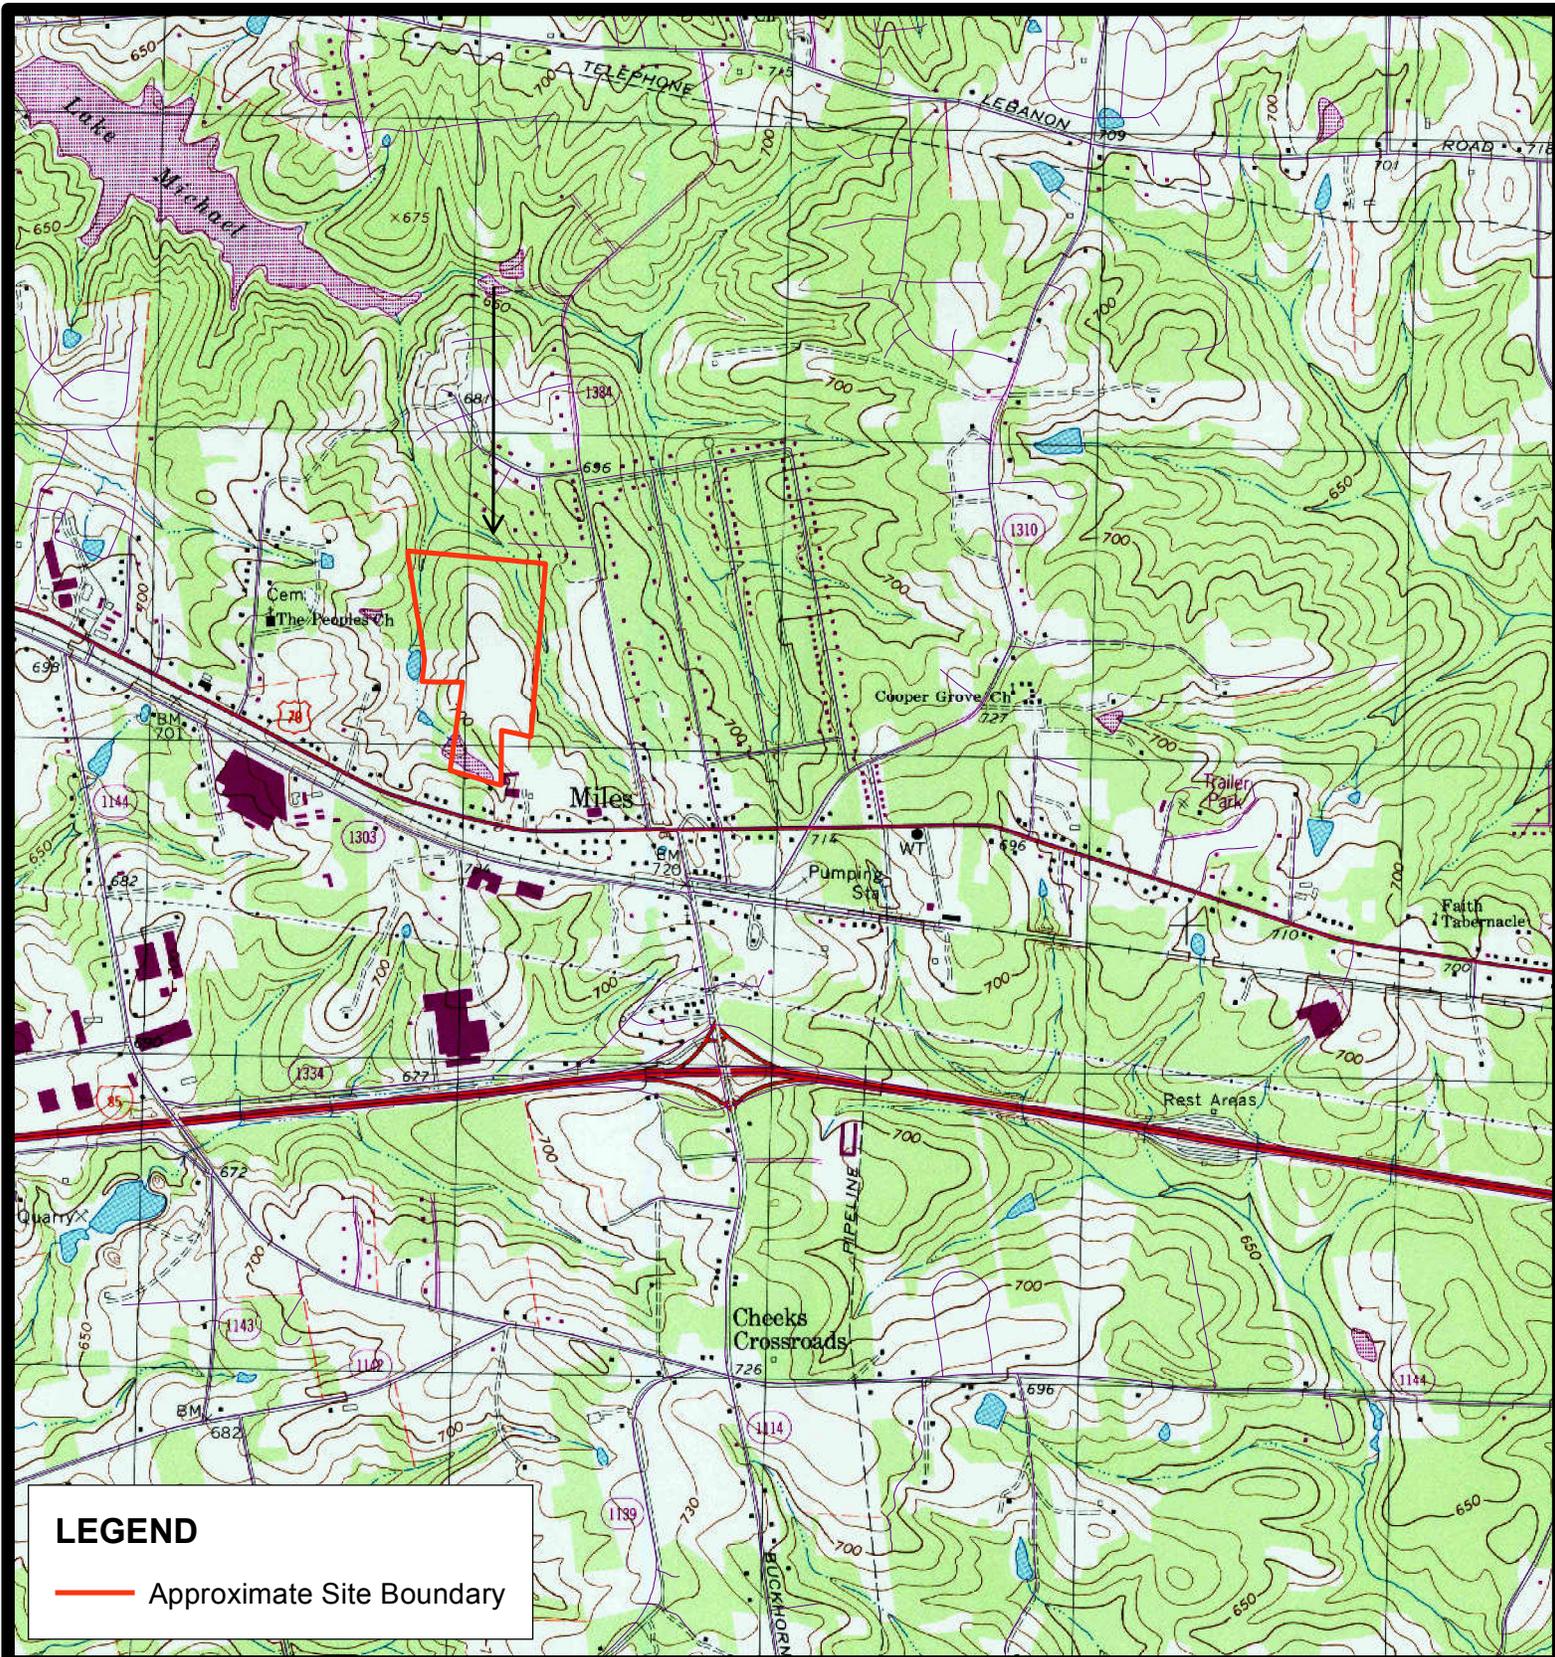
FIGURE 1
LOCATION MAP
 Oakwood Solar Farm, LLC
 Mace Site
 6517 U.S. Highway 70
 Mebane, Orange County, NC
 Env Project #201603

HEnv reviewed the 7.5-Minute series, United States Geological Survey (USGS), Efland, North Carolina Quadrangle (**Figure 1**), dated 2002. According to the topographic map, the site is situated between 660 and 710 feet above mean sea level (MSL). The site slopes downgradient towards the east, north, and west. Two unnamed streams (dashed blue line) are mapped on the northeast portion of the site and along the western boundary of the site, respectively. Several impoundments are mapped along the western stream. The two streams flows north towards Lake Michael. The confluence of the two streams is located approximately 450 feet north of the site. Lake Michael drains to Lower Back Creek (via Mill Creek), which is in the Cape Fear River basin.

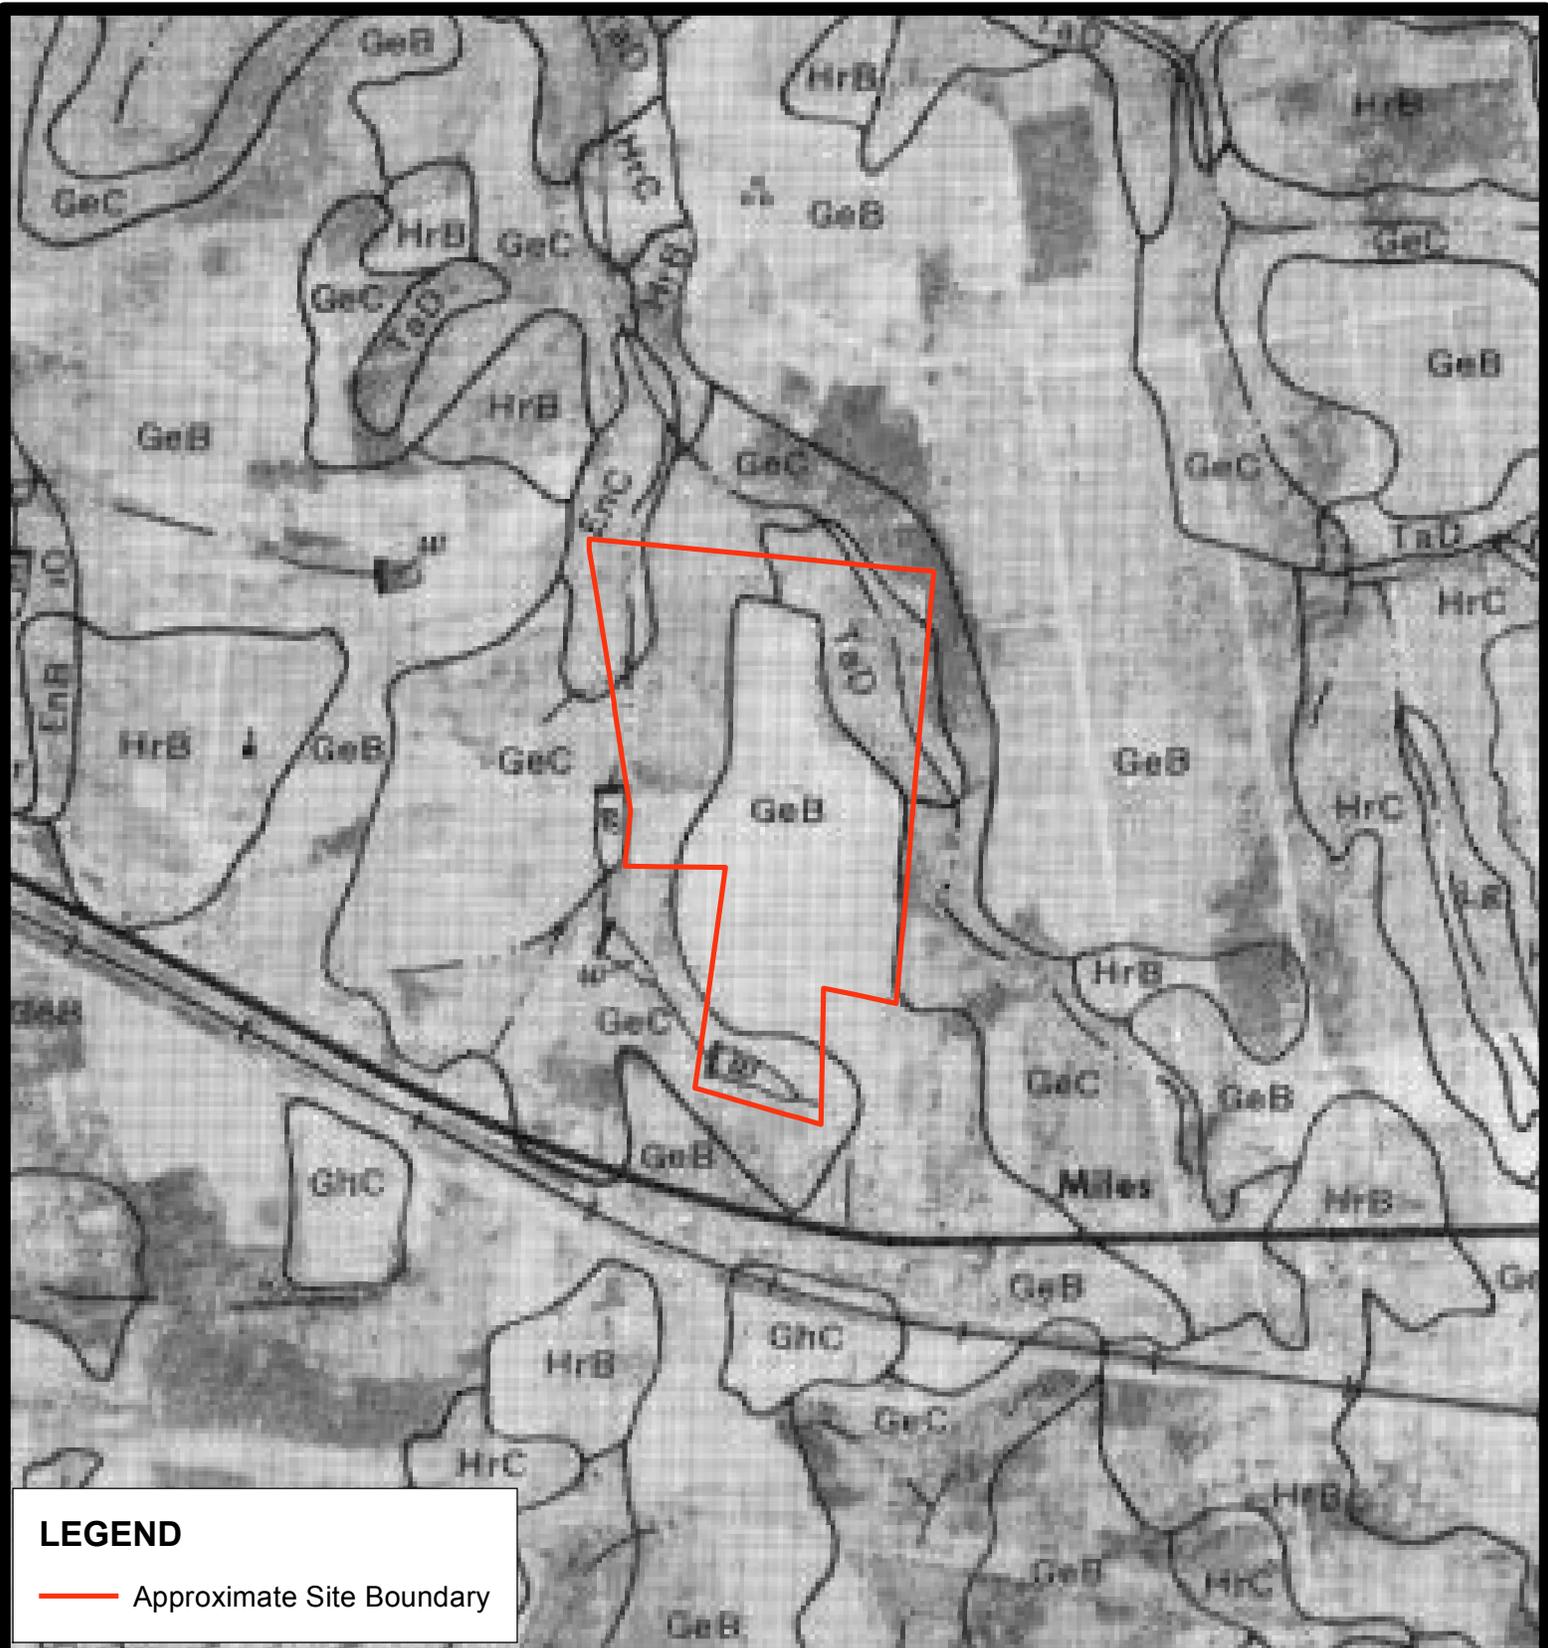
FIGURE 2
ARCHIVED SOIL MAP
 Oakwood Solar Farm, LLC
 Mace Site
 6517 U.S. Highway 70
 Mebane, Orange County, NC
 Env Project #201603

HEnv reviewed the printed Soil Survey for Orange County, North Carolina provided by the United States Department of Agricultural, dated 1977 (**Figure 2**). Two intermittent streams are mapped on the northeast portion of the site and along the western boundary of the site, respectively. Three ponds are mapped along the western stream.

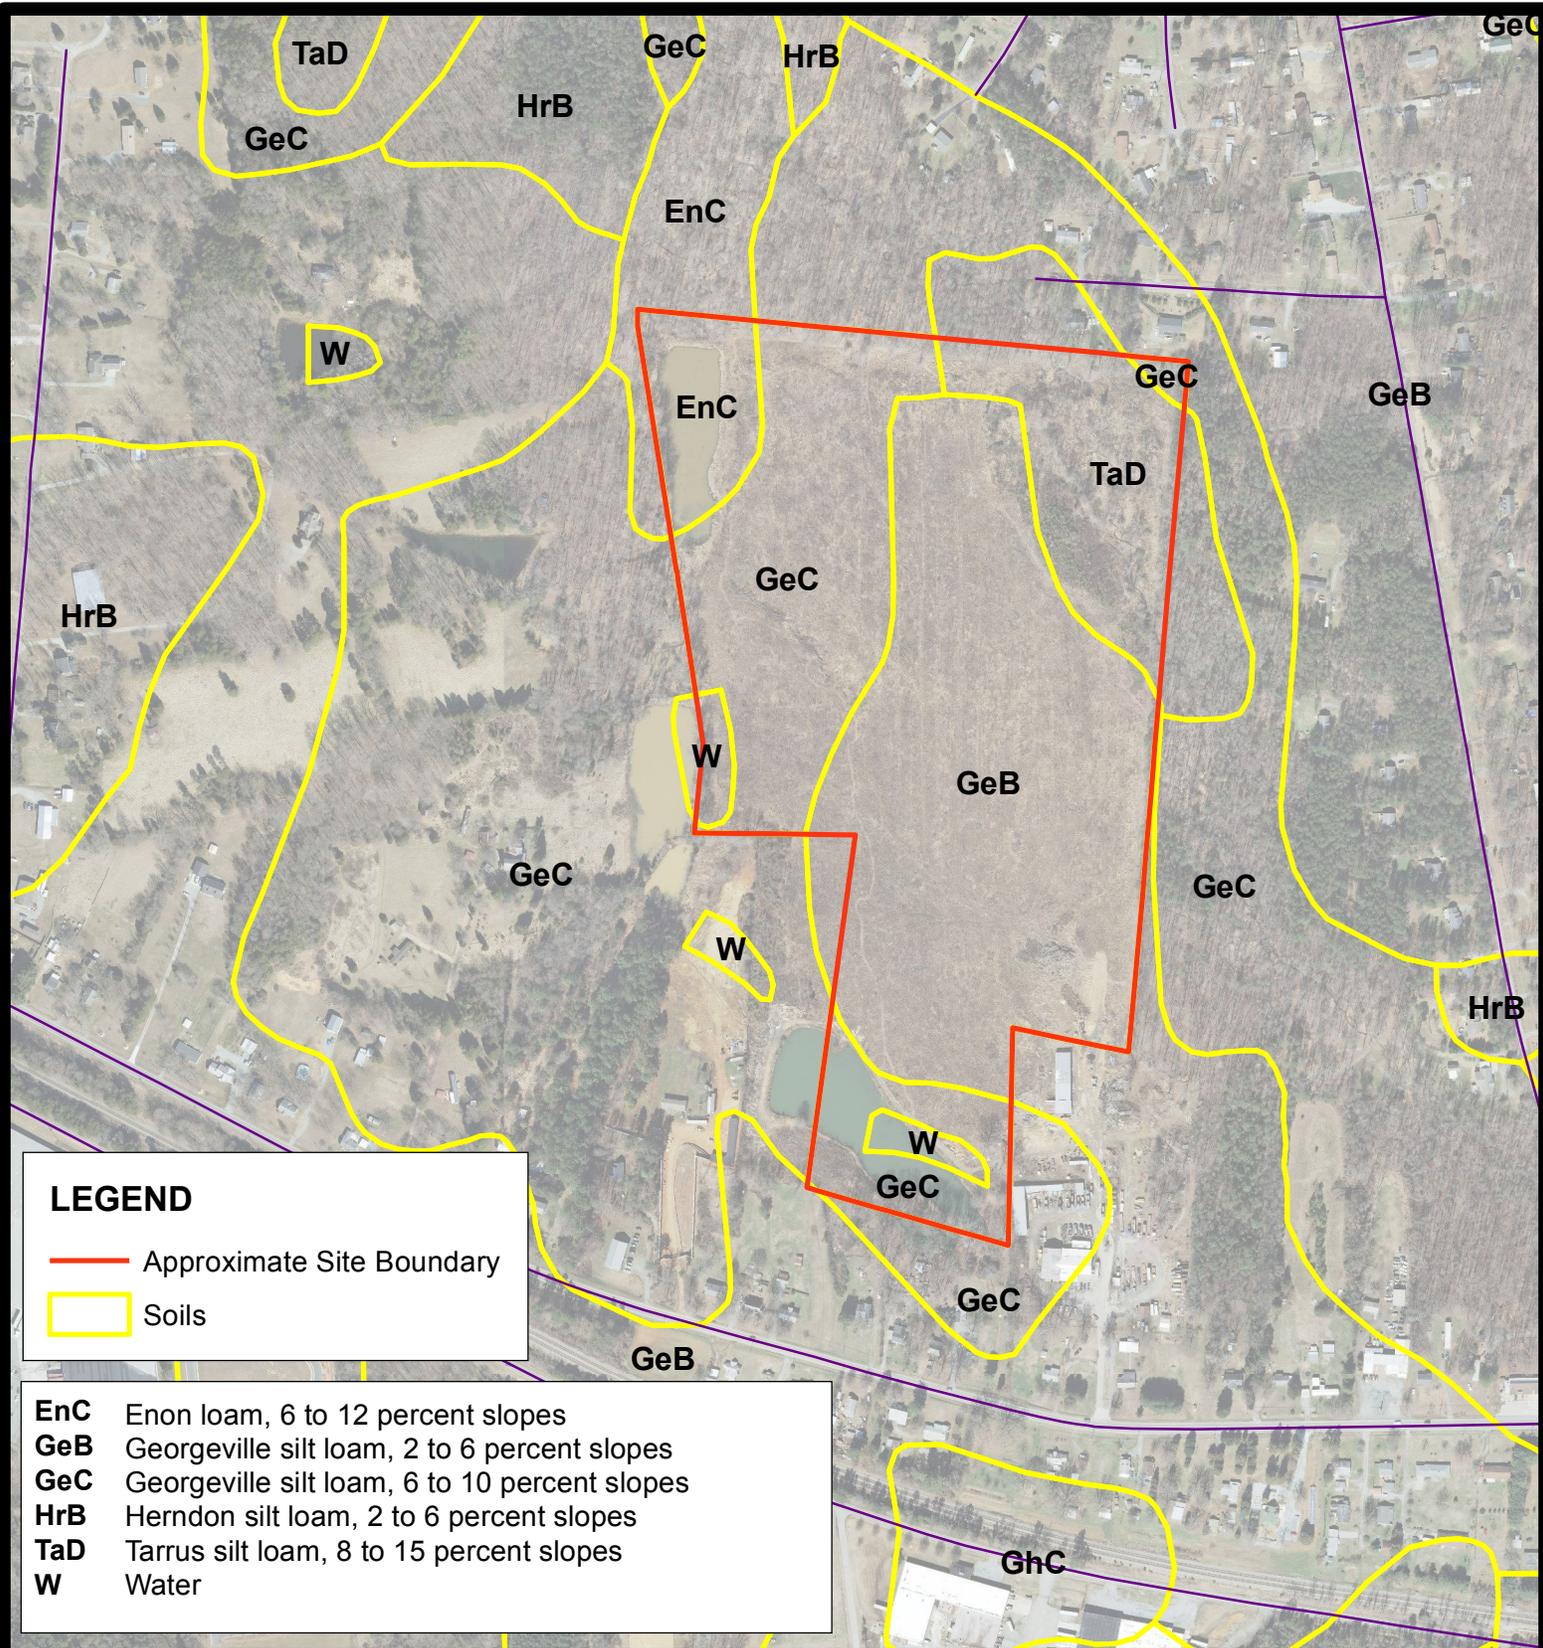
**FIGURE 3
 SOIL MAP**

According to the Natural Resources Conservation Service (NRCS) Web Soil Survey (WSS), there are four soil series mapped within the site boundary (**Figure 3**). Georgeville loam with 2 to 6% (GeB) slopes and 6 to 10% slopes (GeC) is mapped throughout the majority of the site. Tarrus silt loam (TaD) is mapped on the northeast portion of the site. Enon loam (Enc) is mapped on the northwest portion of the site.

Georgeville loam is a very well drained soil found on gently sloping to moderately steep Piedmont uplands. Soils of the Tarrus series are deep and well drained. These soils are on uplands of the Piedmont physiographic region. The Enon series consists of a very deep, well drained soil found on ridgetops and side slopes in the Piedmont.

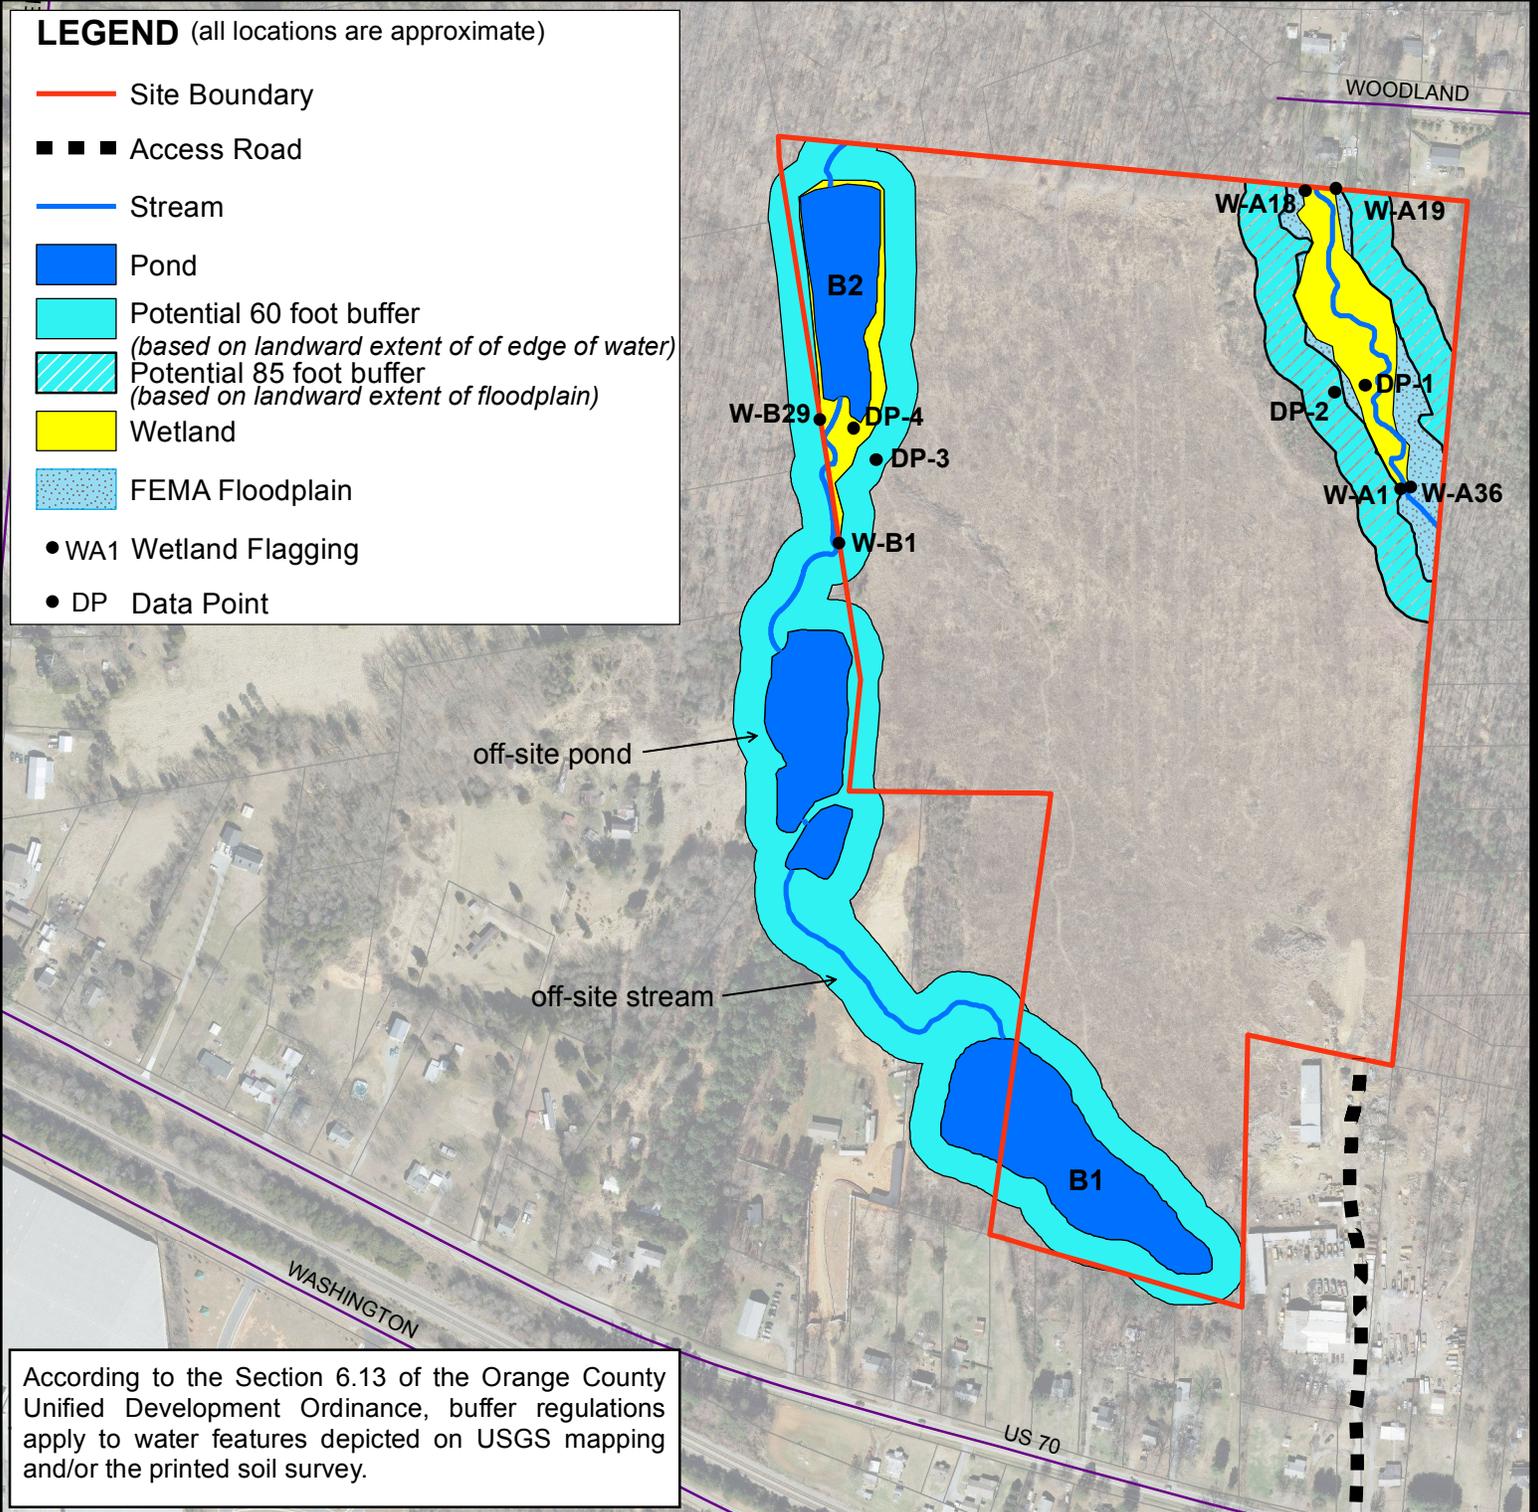
FIGURE 5
WETLAND DELINEATION

HEnv identified two wetland areas, two ponds, and two streams within the site boundary (**Figure 5**). Wetland Area A is located on the northeast portion of the site. Stream A flows north,

through Wetland Area A, towards Michael Creek. Based on observations in the field, Stream A appears to be perennial and is a buffered feature.

Pond B1 is located on the southern portion of the site. Pond B1 continues off-site to the west and drains to an unnamed stream (Stream B). There are no peripheral wetlands around Pond B1. There are two man-made ponds located west of the site along Stream B. Stream B enters the northwestern portion of the site and drains to Pond B2. Stream B appears to be intermittent. Wetland Area B is located around the peripheral of Pond B2. The ponds, stream, and wetlands along the western boundary of the site will likely have a vegetative buffer.

The soils in the wetland areas have low chroma and low value colors. The wetland areas are dominated by hydrophytic vegetation and exhibit wetland hydrology indicators. The vegetation in Wetland Area A is dominated by trees and saplings. The vegetation in Wetland Area B is dominated by herbaceous wetland species. Wetland Determination Data Forms Data Forms that support our findings are included as an attachment. DP-1 and DP-4 represent the upland conditions observed throughout the site. DP-2 and DP-3 represent the wetland conditions. HEnv marked the wetland boundaries with pink and orange surveyor tape. The wetland flag labeling scheme is depicted on Table 1.

According to the Section 6.13 of the Orange County Unified Development Ordinance, buffer regulations apply to water features depicted on USGS mapping and/or the printed soil survey.

- HEnv identified two wetland areas within the site boundary; Wetland Areas A and B. It is estimated that jurisdictional wetlands occupy 1 to 2 acres of the site. Jurisdictional wetlands are regulated by the USACE and the DWR. Additionally, Pond B1 and B2 appear to have been constructed along a former stream channel and will likely be deemed jurisdictional by the USACE. The ponds encompass approximately 4 to 5 acres.
- The jurisdictional wetland boundaries were preliminary flagged in the field and are depicted on Figure 5. As a preliminary drawing, the wetland boundary is subject to a field confirmation and a written jurisdictional determination (JD) from the USACE. Additionally, a Significant Nexus determination will need to be conducted during the JD process, to determine the limit of the USACE's jurisdiction.

- According to the UDO, buffer regulations are applicable to streams and water features depicted on the USGS map and/or printed soil survey. For slope values greater than 7.5%, an 85-foot buffer extends from the edge water, edge of floodplain, or edge of wetland, which ever extends farther from the stream centerline. For slope values less than 7.5% a 60-foot buffer extends from the edge water, edge of floodplain, or edge of wetland, which ever extends farther from the stream centerline.
- The site drains to Lake Michael, which has been classified by the DWR as waters used for consumption (WS-II), nutrient sensitive waters (NSW), and a high quality watershed (HQW). Additional buffer regulations and stormwater requirement apply to sites in this watershed. The stream/pond buffers are based on the density of development and stormwater permitting requirements.

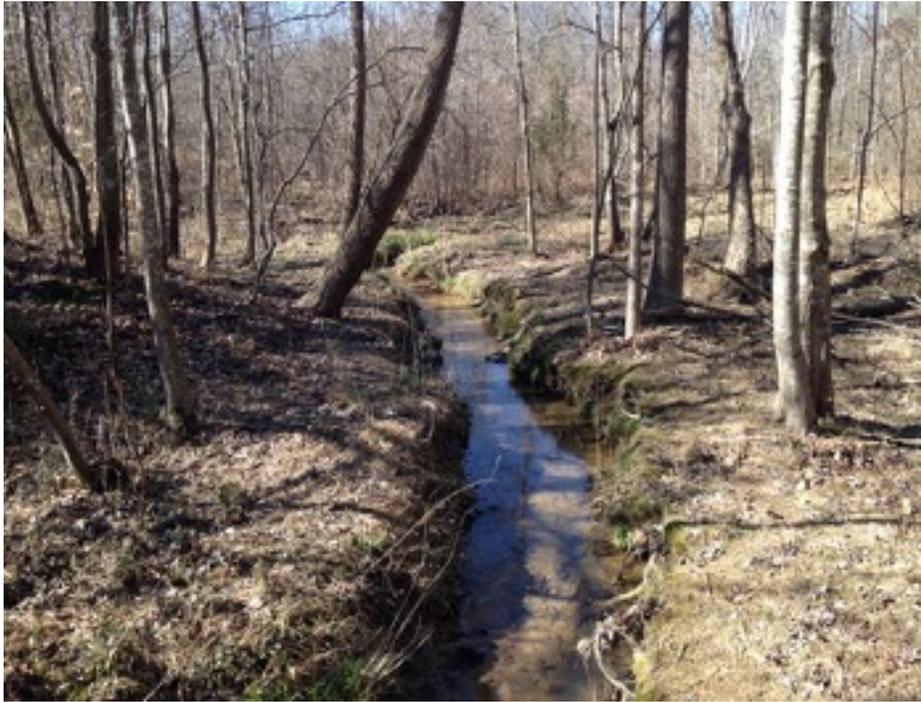
Facing north along Stream A, within Wetland Area A.

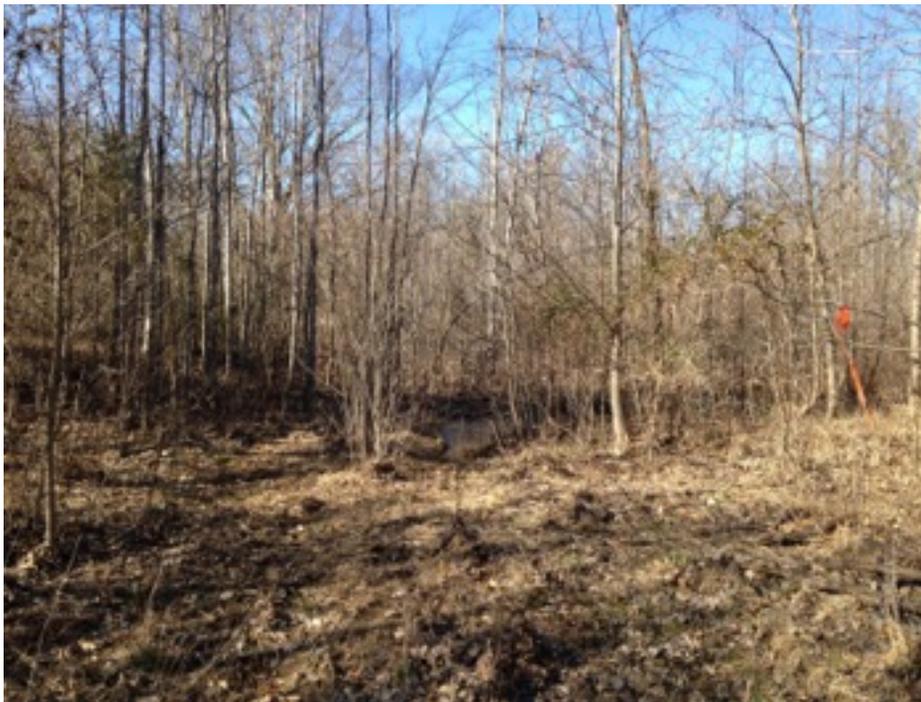
Wetland Area A. The sloping uplands are depicted on the left side of the image.

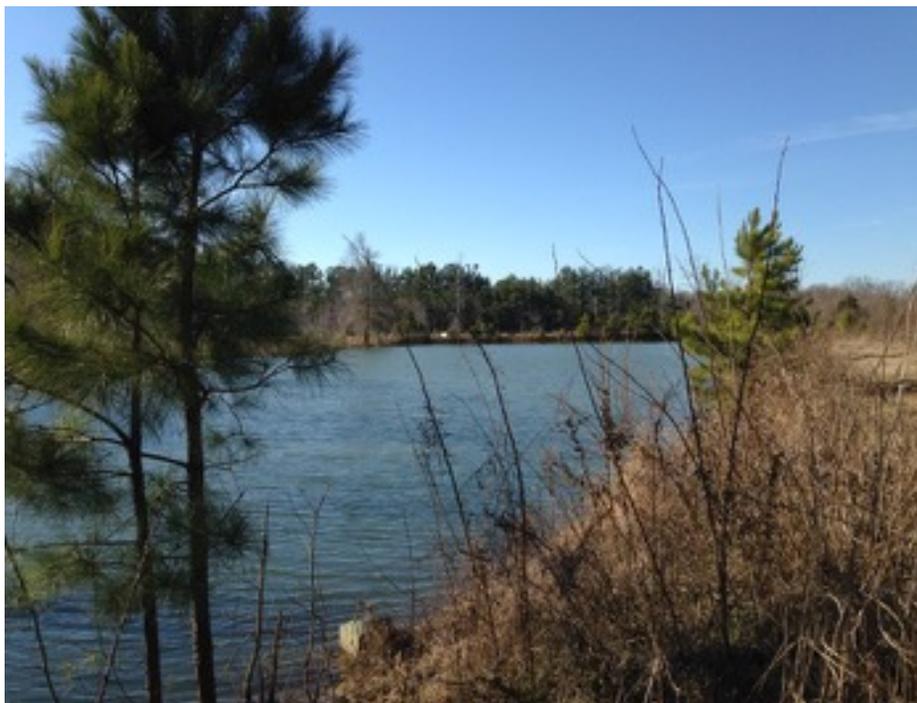
Facing west along the north side of Pond B1.

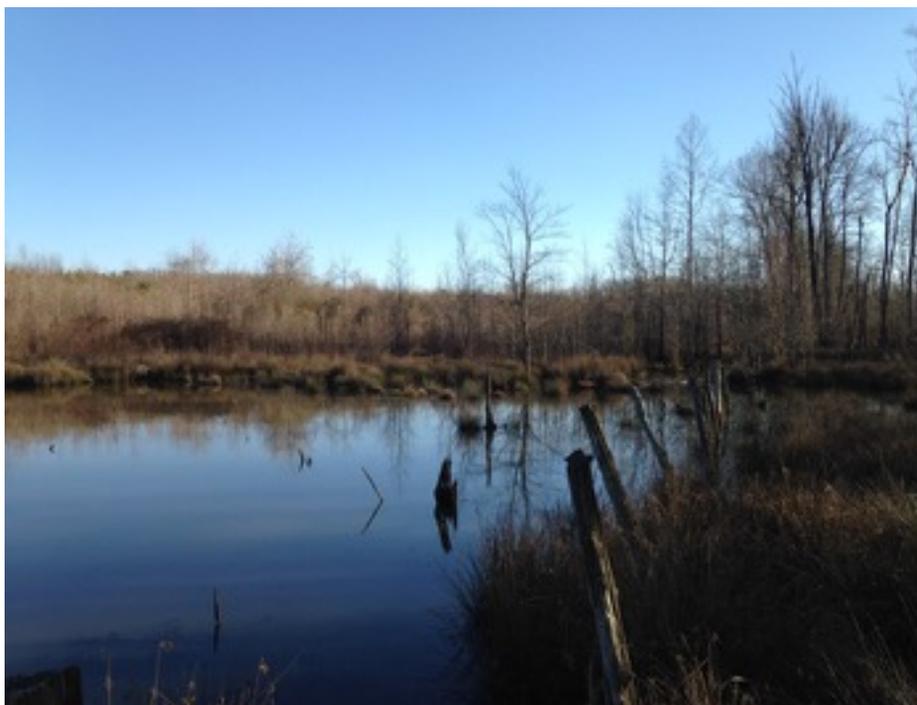
Pond B2 with associated wetland fringe (Wetland Area B).
