Orange County Environment and Agricultural Center Preliminary Study

Orange County Asset Management Services

HH Architecture
January 12, 2017
HH Project #15-082

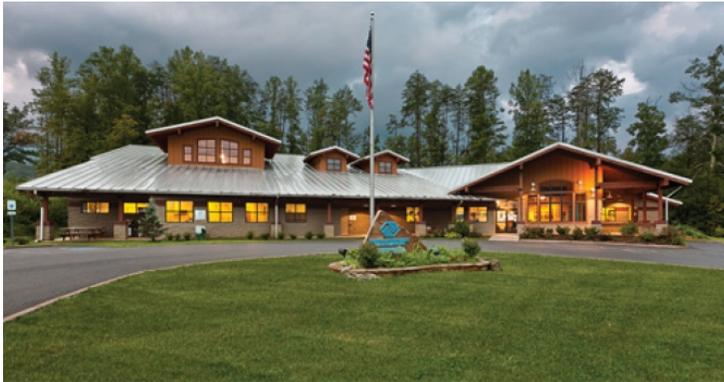
Boys and Girls Club of the Smokey Mountains, Gatlinburg, TN

Today, all buildings contain some number of pre-manufactured components, and there is a blend of field-built and factory work from a variety of trades and suppliers. Pre-engineered steel construction shifts more of the balance of work under single manufacturer, with more work performed in the factory. However, a substantial number of components remain field-fabricated, including the building foundations, enhanced exterior cladding, the interior upfit work, and any custom exterior components. There are many benefits and limitations when evaluating pre-engineered construction:

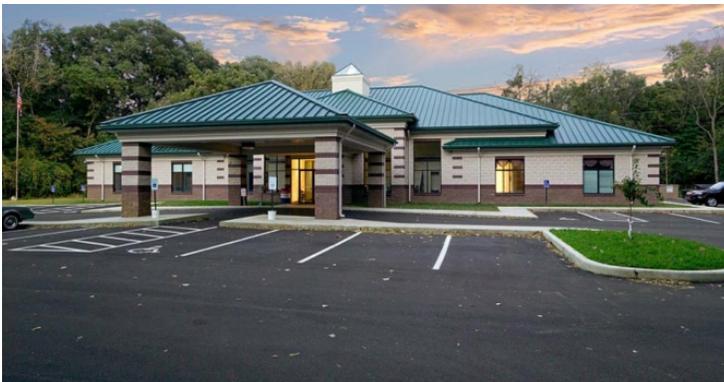
American Legion Post 11, Lafayette, IN

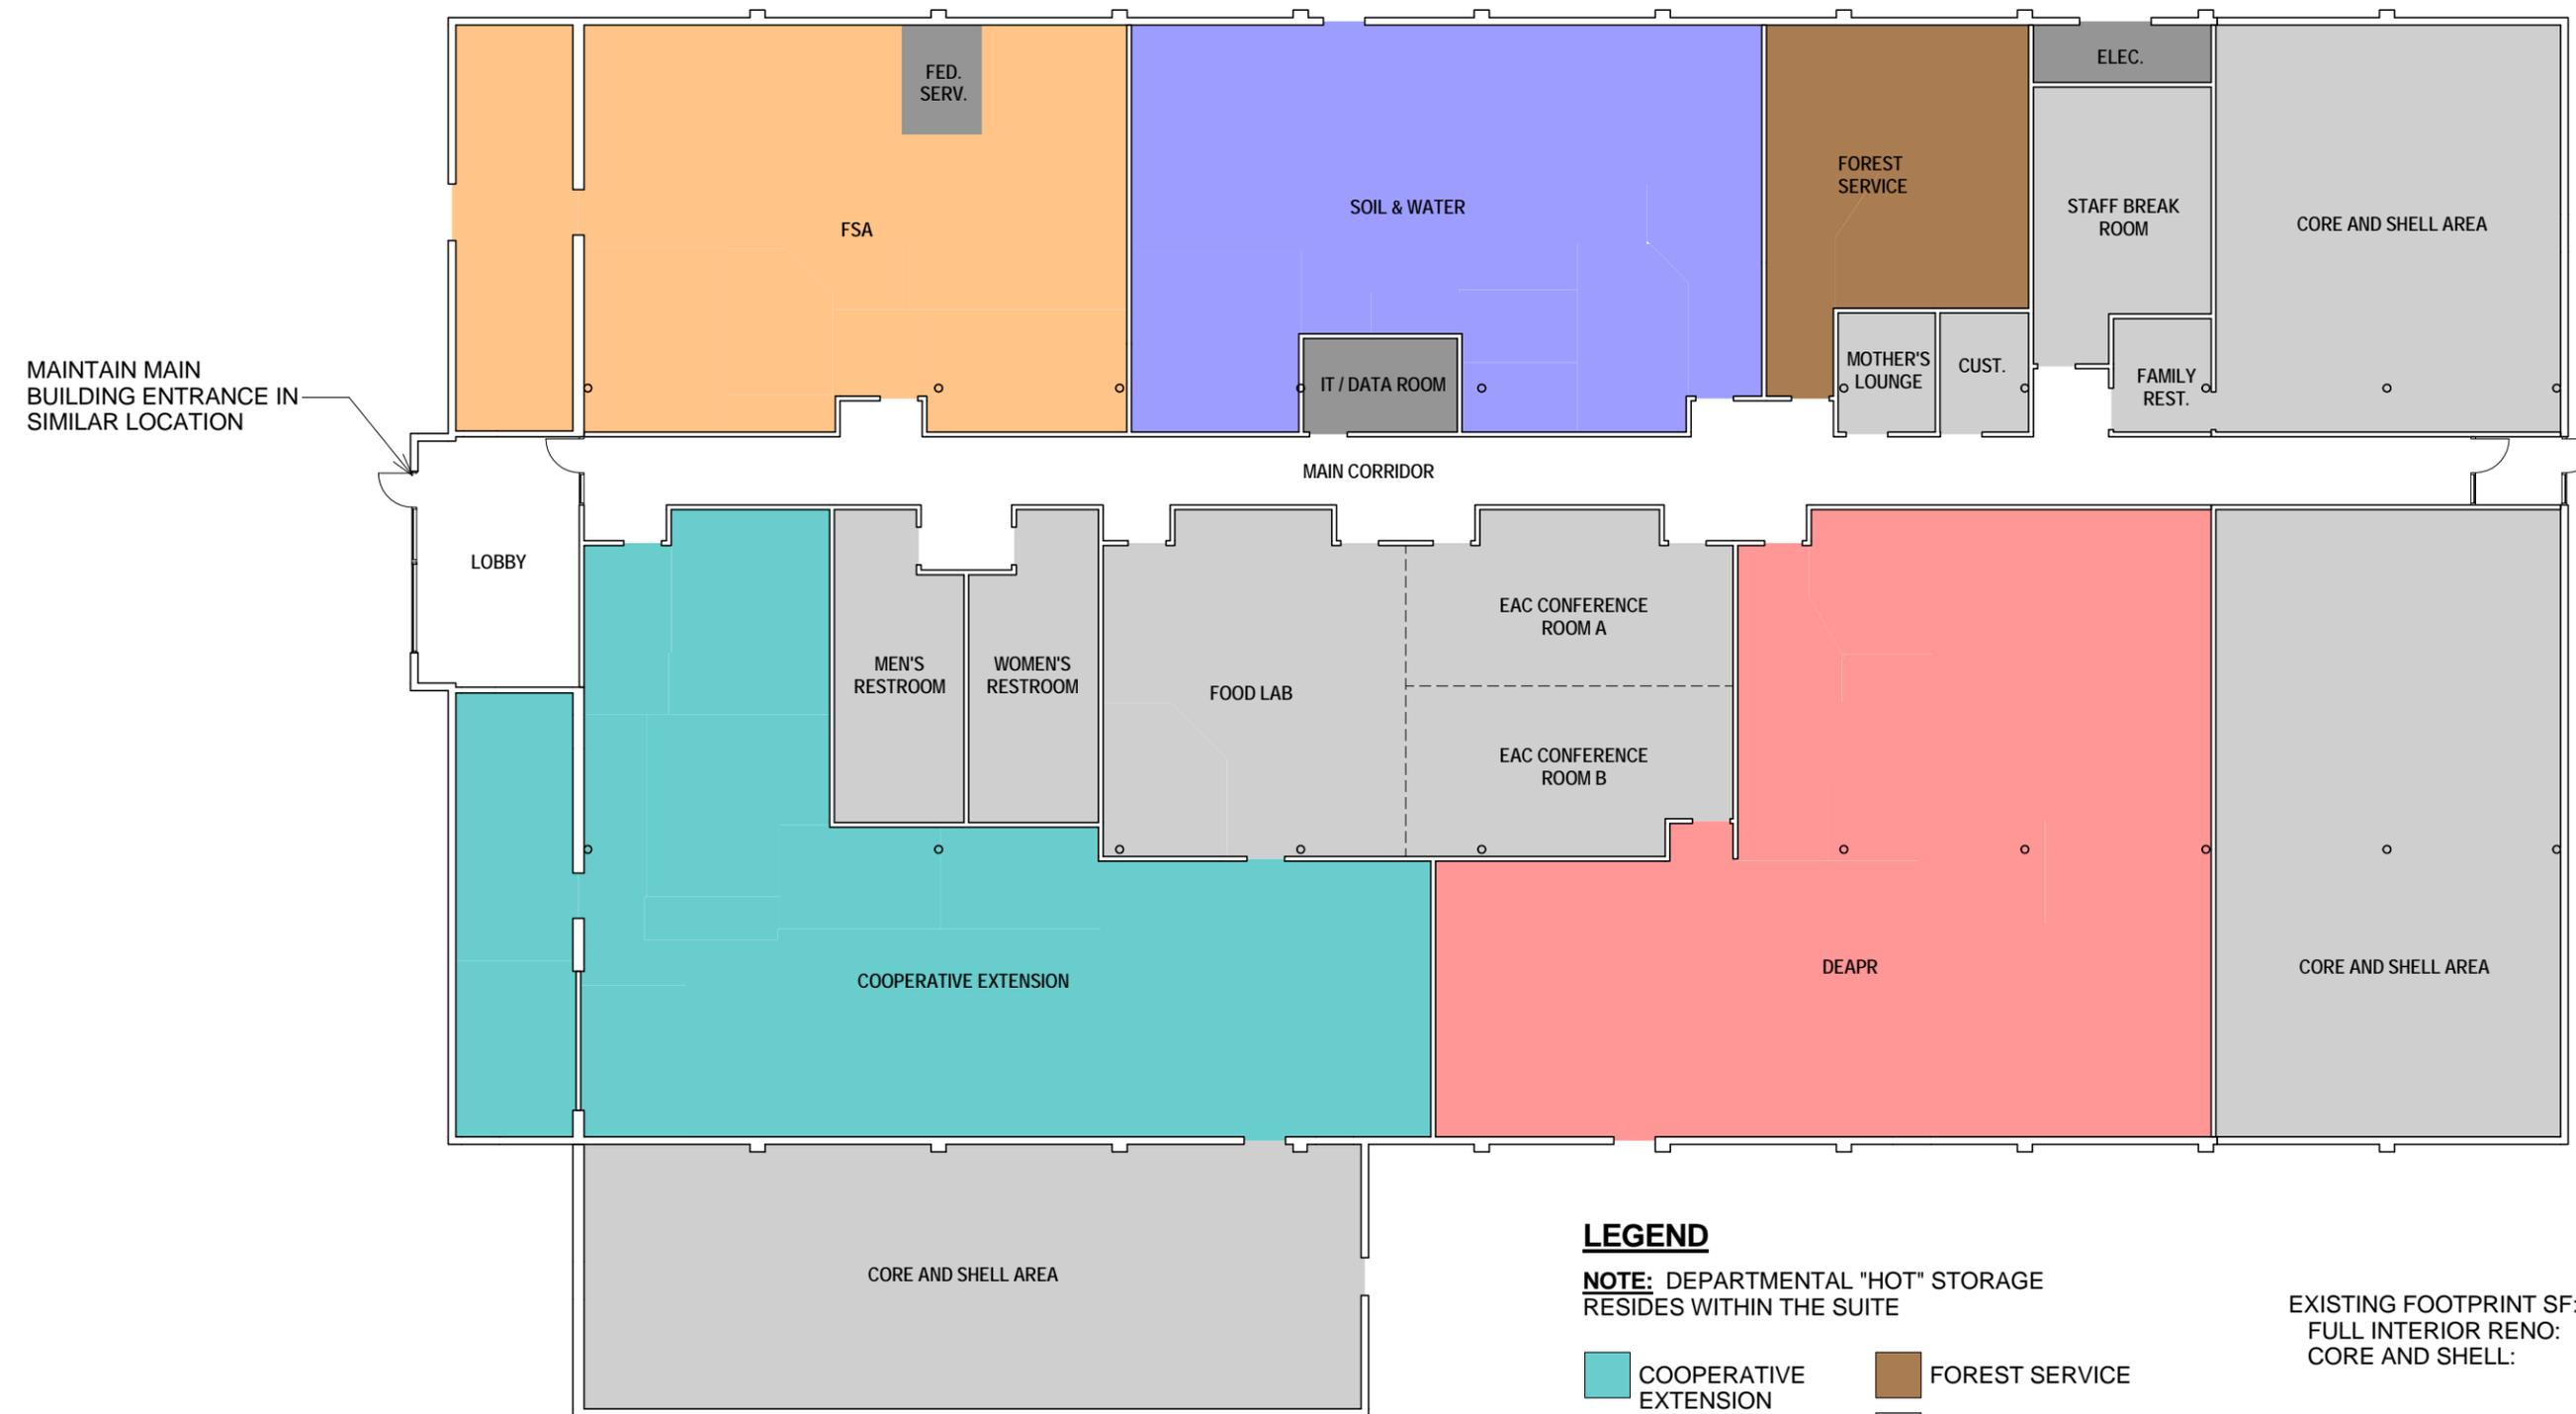
MAINTAIN MAIN BUILDING ENTRANCE IN SIMILAR LOCATION

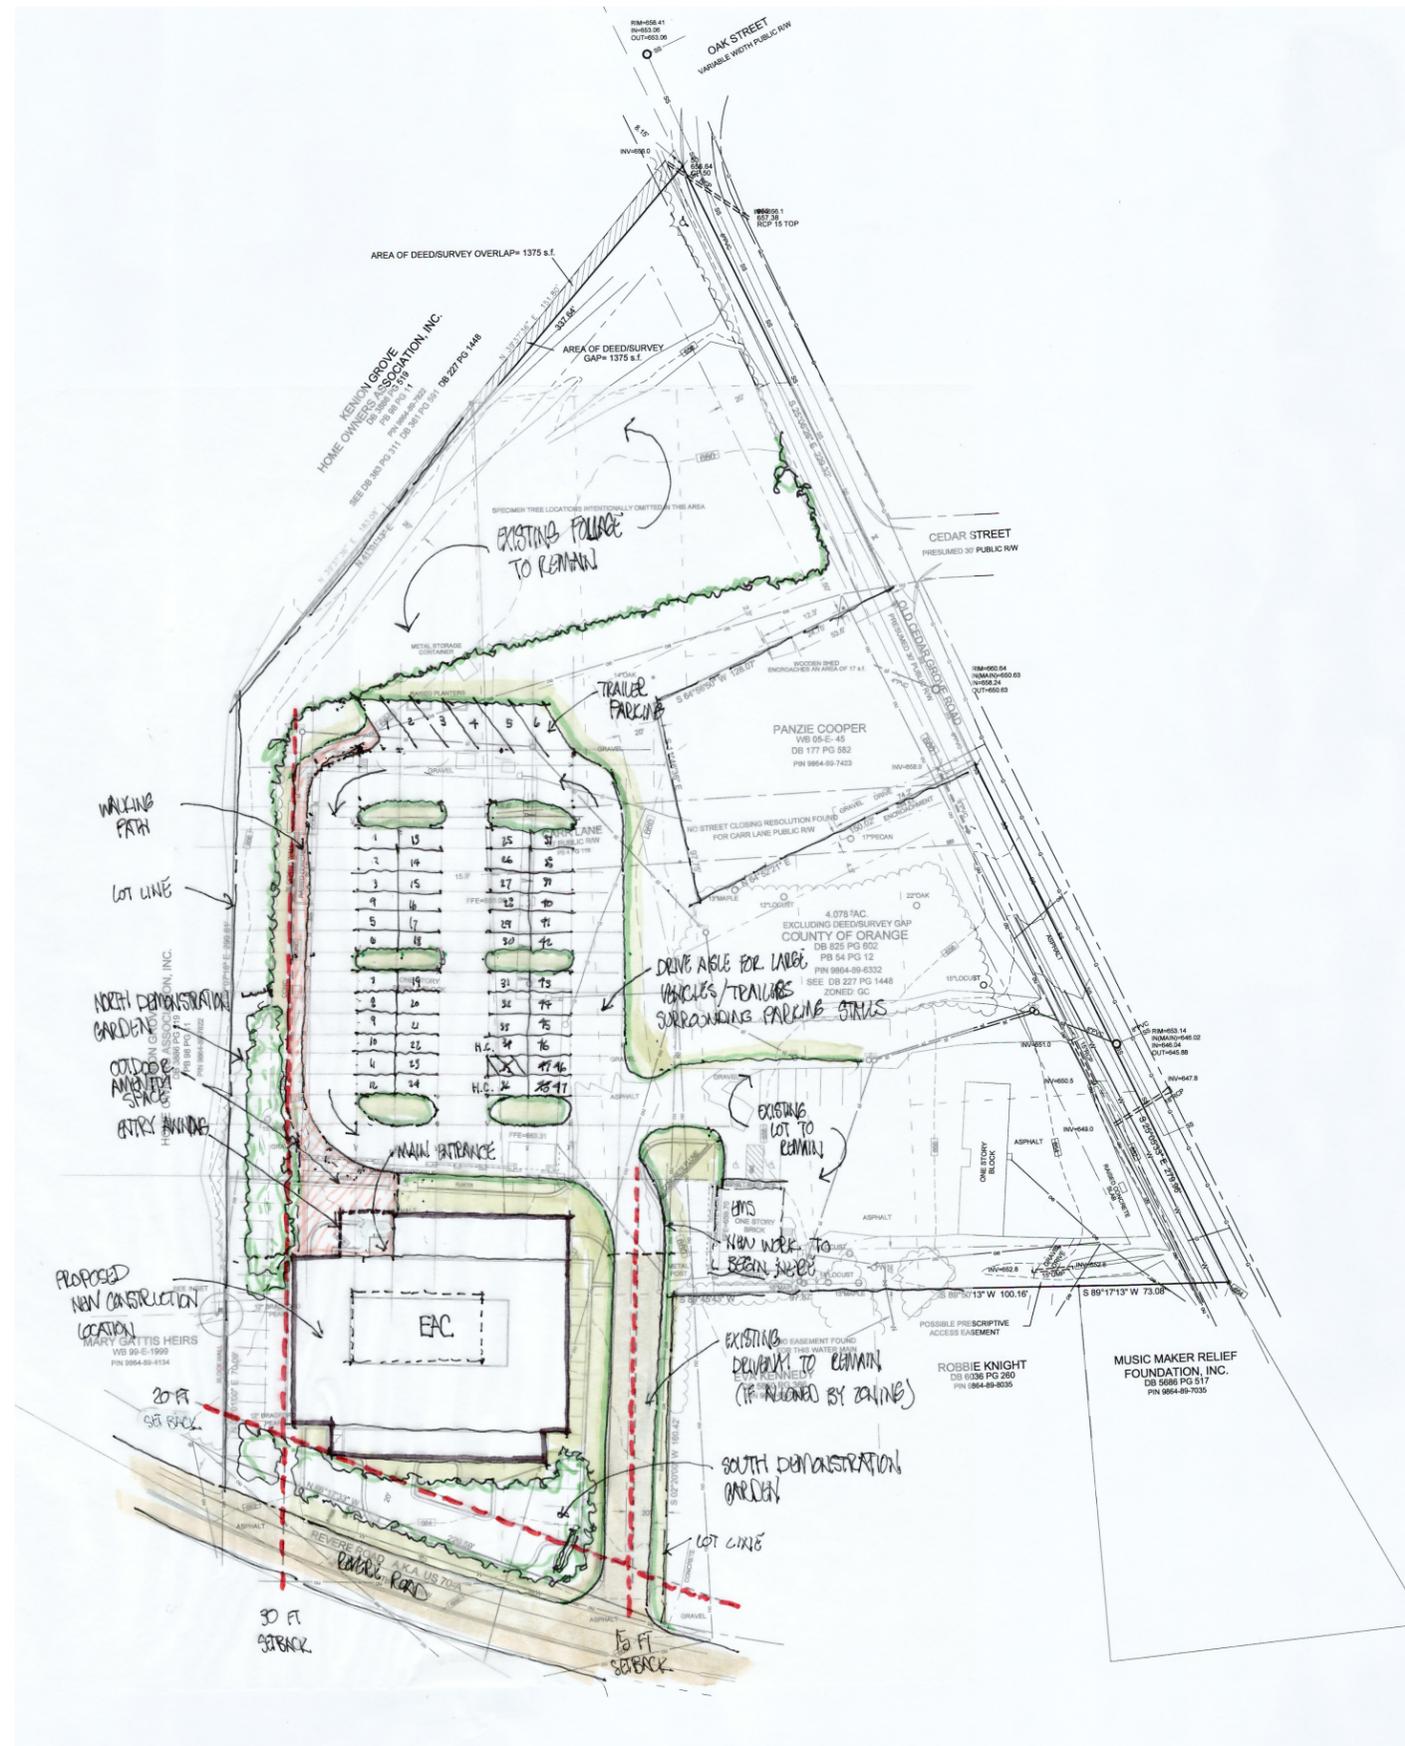
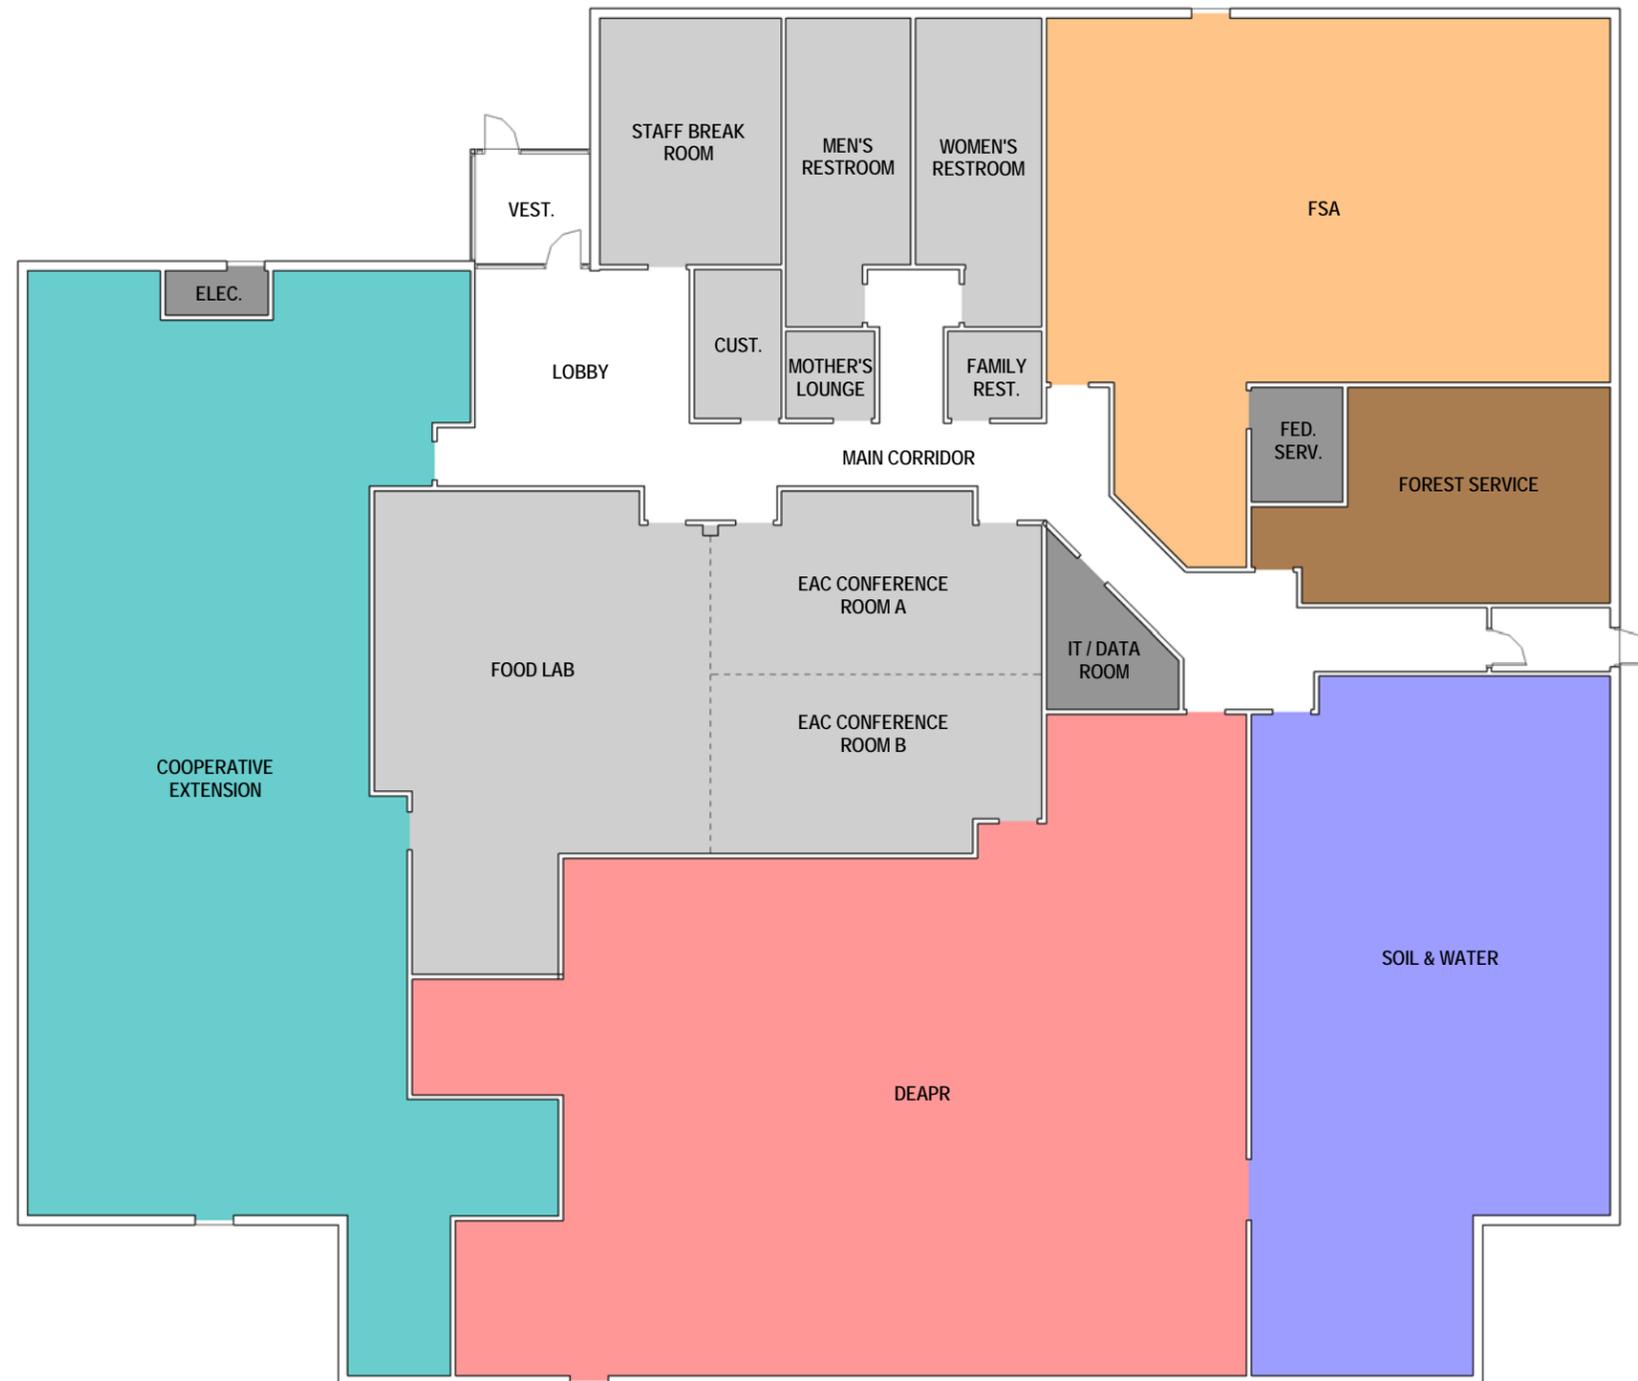
NEW CONSTRUCTION SF: 15,030 GSF

The new construction options consider both conventional and pre-engineered solutions for the complete removal and replacement of the existing facility on the same site. Both options consider a similar footprint for the new building, as well as a similar overall building size.
